**U.S. GENERAL SERVICES ADMINISTRATION
FEDERAL CENTER SOUTH
GROUNDWATER MONITORING ASSESSMENT
NOVEMBER 2010 EVENT
FINAL REPORT**

U.S. GENERAL SERVICES ADMINISTRATION
FEDERAL CENTER SOUTH
GROUNDWATER MONITORING ASSESSMENT
NOVEMBER 2010 EVENT
4735 EAST MARGINAL WAY SOUTH
SEATTLE, WASHINGTON 98134
FINAL REPORT

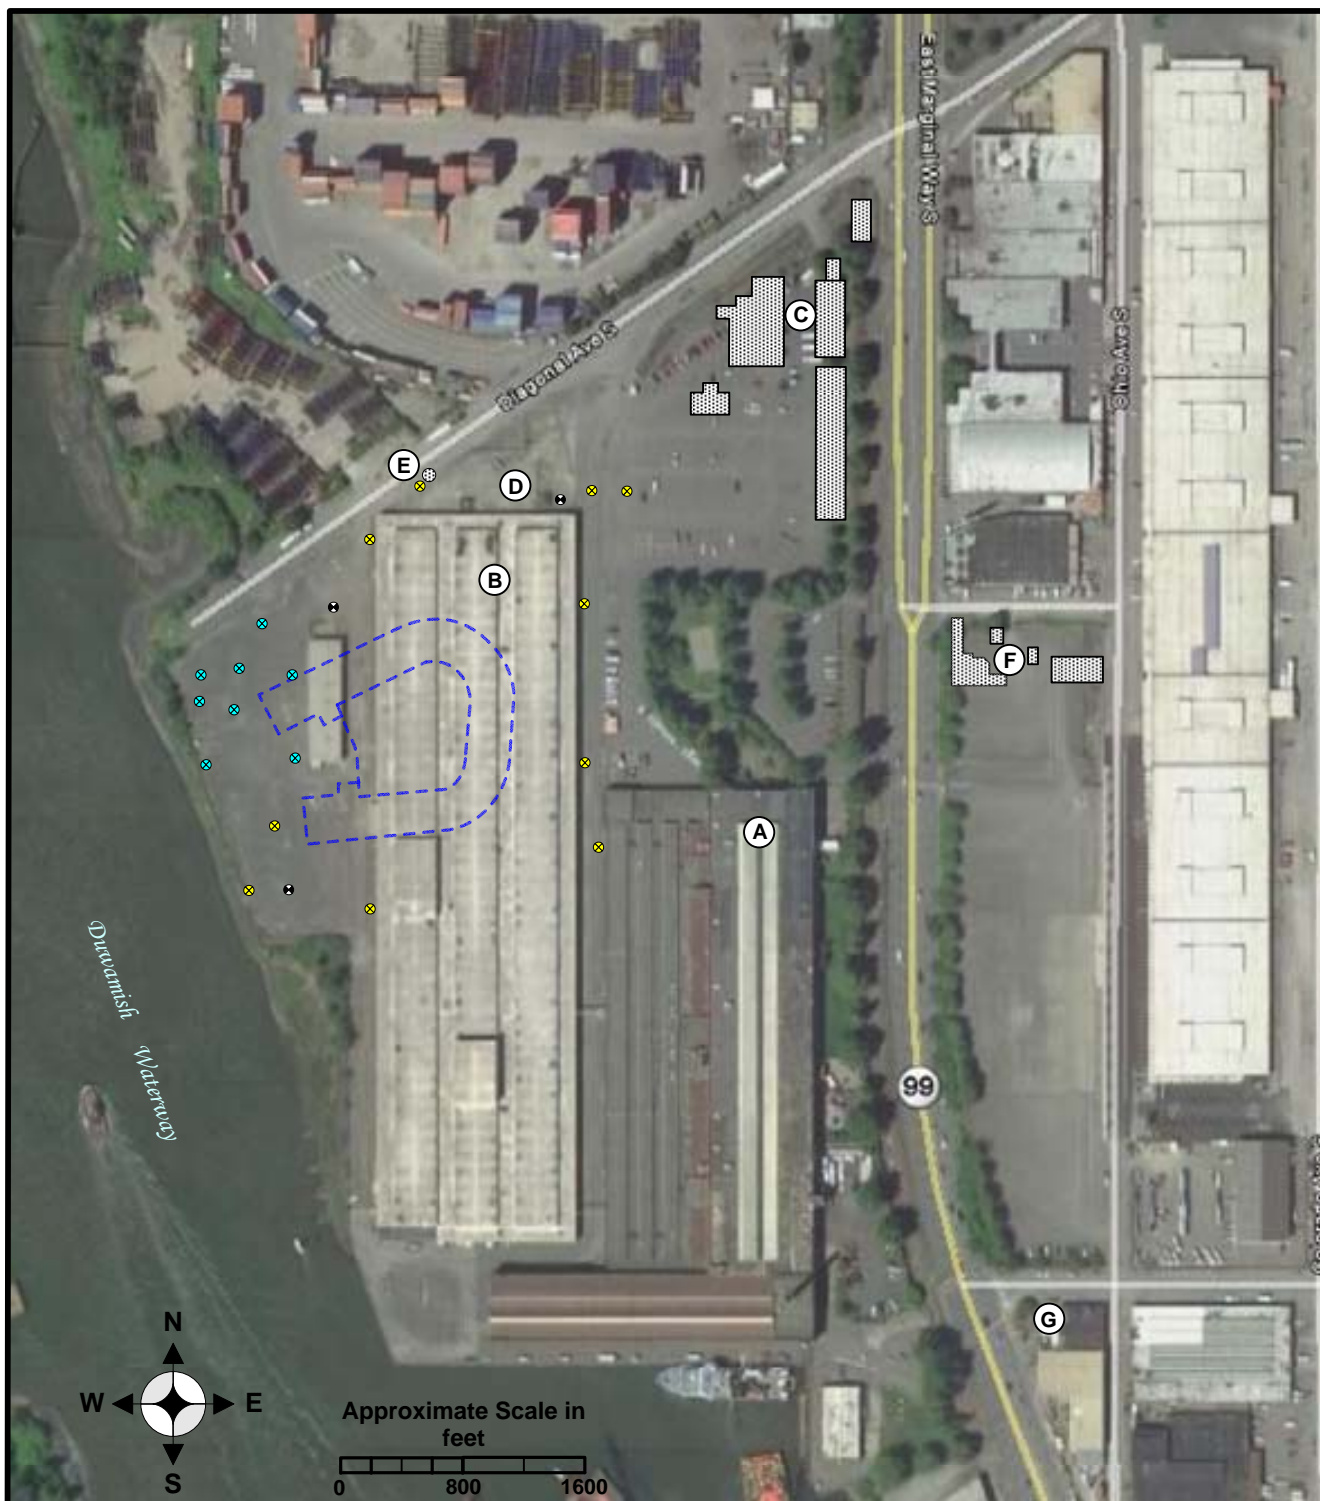
FIGURE 3: POTENTIAL CONTAMINATION SOURCE AREAS

Based on the results of the historical records review, the distribution and concentration of documented vinyl chloride in groundwater, and the presence of related halogenated VOCs, EHSI concluded that there three viable sources for vinyl chloride in groundwater within the Federal Center property. These source areas are:

Based on historical records review EHSI identified seven potential on- and off-site sources associated with the use of solvents related to halogenated VOCs. These seven potential source areas are described below and their locations are shown on Figure 3, with the letter designation corresponding to the source area.

| <p>(A) Former garage used during vehicle assembly and missile manufacturing.</p> <p>(B) Storage of dry-cleaning supplies in Bldg 1202.</p> <p>(C) Former property and vehicle maintenance shops.</p> <p>(D) Drums and hazardous substances stored on loading dock area.</p> | <p>(E) A tall AST of unknown contents.</p> <p>(F) Historical paint manufacturing plant.</p> <p>(G) Former Totem Equipment.</p> |

EHSI recommends that an estimate of hydraulic conductivity be made for groundwater wells FC-2, FC-3, and FC-7 to determine if vinyl chloride detected in these wells will impact the stormwater retention design for the Federal Center South property. We also recommend that an estimate of hydraulic conductivity be made for groundwater monitoring well FC-9. The hydraulic conductivity will be used to ascertain the likelihood of vinyl chloride detected in this wells to migrate into the Duwamish Waterway, located west and hydraulically down-gradient of the well.
